Report Number NTSB-AAR-82-8

Report Title Air Florida, Inc., Boeing 737-222, N62AF, Collision with 14th Street Bridge, Near Washington National Airport, Washington, D.C., January 13, 1982.

Organization Name National Transportation Safety Board Bureau of Accident Investigation Washington, D.C. 20594

Report Type Aircraft Accident Report January 13, 1982

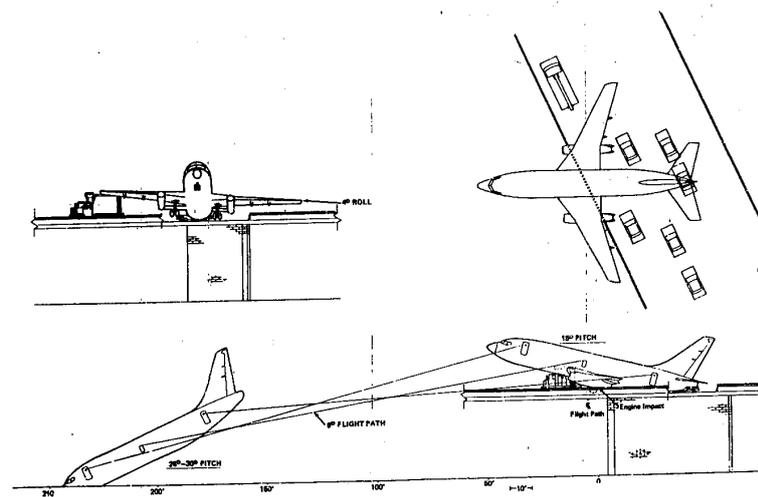
Figure 2. -- Aircraft Impact Attitude.

As the aircraft descended, the right wing was structurally damaged when it hit the boom truck, and shortly thereafter, the aircraft struck the steel barrier and railing on the west side of the 14th Street Bridge at an elevation of about 37 feet mean sea level. Fragments of the right wing remained on the bridge. The remainder of the wreckage sank in the Potomac River in about 25 to 30 feet of water. The wreckage area was confined to the south side of the river between the 14th Street Bridge and the Center Highway Bridge of the George Mason Memorial Bridge. (See figure 4.)

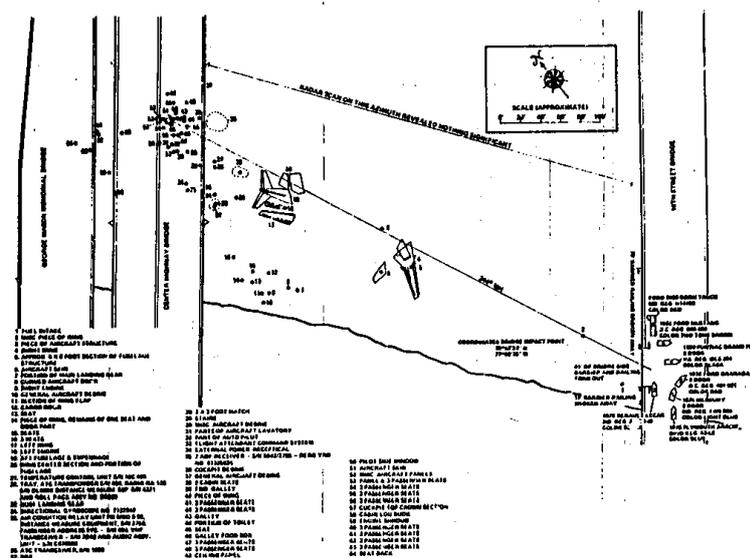
Figure 4. -- Position of Wreckage in the Water.

After initial impact, the aircraft broke into several major pieces. The fuselage broke into four major pieces which included: (1) nose section with cockpit; (2) fuselage section between nose section and wing center section; (3) fuselage-to-wing intersection; and (4) aft body structure with empennage attached. The wing structure was separated into three major pieces which included: (1) left wing outboard of the No. 1 engine, including all associated flight control surfaces; (2) wing center section, lower surface, including wing lower surface stubs between the No. 1 engine mounts and the No. 2 engine mounts; and (3) right wing outboard of the No. 2 engine with the outboard 20 feet mostly disintegrated. The left main landing gear was separated from the wing, and the right main gear remained attached except for the wheels and oleo piston. The nose landing gear and its attaching structure were separated from the nose section. Both engines and their pylon structures were separated from the wings. There was no evidence of fire on any of the recovered structure.

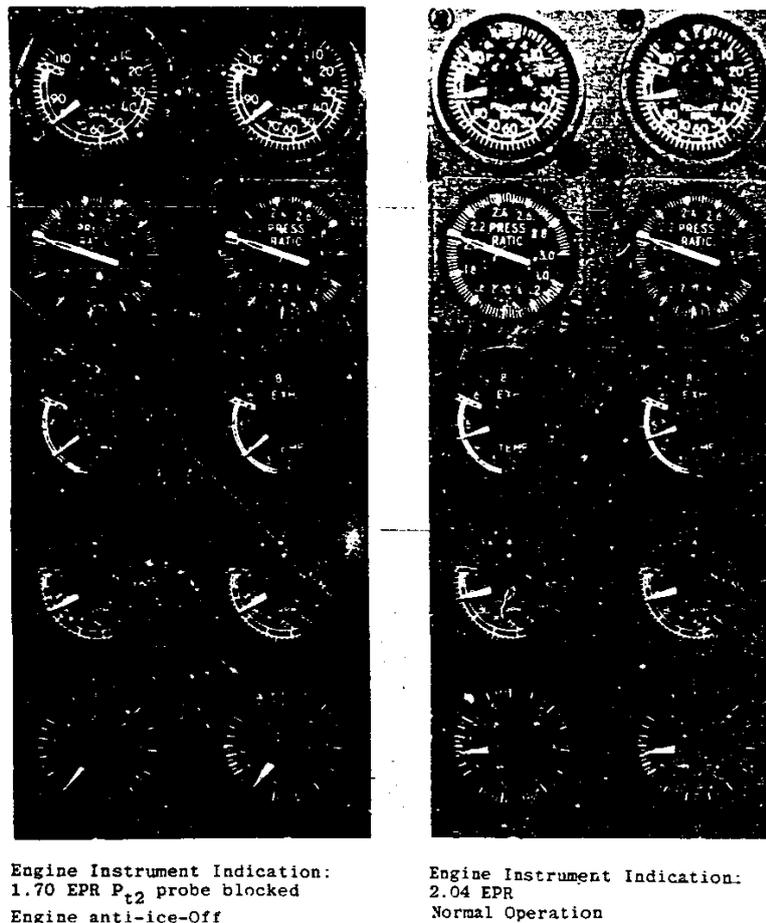
Figure 6.—Comparison of Instrument Readings -- 1.70 HPR vs. 2.04 EPR.

With the engine operating, a false indication of the actual EPR can be indicated in the cockpit when ice blocks the inlet probe. Under this condition, the P_{t_2} probe is vented to the nose cone pressure through a siphon-break hole in the sense line. The interior of the engine nose cone is vented to the engine inlet static pressure, which is lower than the engine inlet total pressure normally sensed by the P_{t_2} system. Under severe icing conditions, if the engine inlet anti-icing air bleed system is shut off and the normal P_{t_2} sensing port is blocked with ice, the P_{t_2} sensor will sense the lower pressure at the vent port in the nose cone. The cockpit indication may become slightly erratic as icing begins to block the probe and will indicate a significantly higher reading when ice fully blocks the probe. Tests have demonstrated that with a blocked probe at takeoff, engine power can indicate an EPR of about 2.04 with the engine actually operating at an EPR ratio of 1.70. Under these circumstances, a pilot would unknowingly attempt takeoff at a considerably lower thrust than desired. However, the pilot has available other indications of engine operation displayed in the cockpit, such as a lower N_1 , N_2 , EGT, and F/F consistent with the reduced engine thrust. [\(See figure 6.\)](#)

Should the pilot activate the engine inlet anti-icing system with a blocked probe, he would immediately notice a substantial drop in the indicated EPR, incorrectly indicating a low engine thrust as long as the normal P_{t_2} sensing port remains blocked. This results from the introduction of engine anti-icing air flow into the nose cone and resultant increase in the pressure in the interior of the nose cone. This pressure is higher than that which would be sensed at the normal P_{t_2} port. Falsely low indicated EPR's have been detected by pilots when they found that they were unable to set takeoff power without exceeding redline N_1 , N_2 , and EGT.

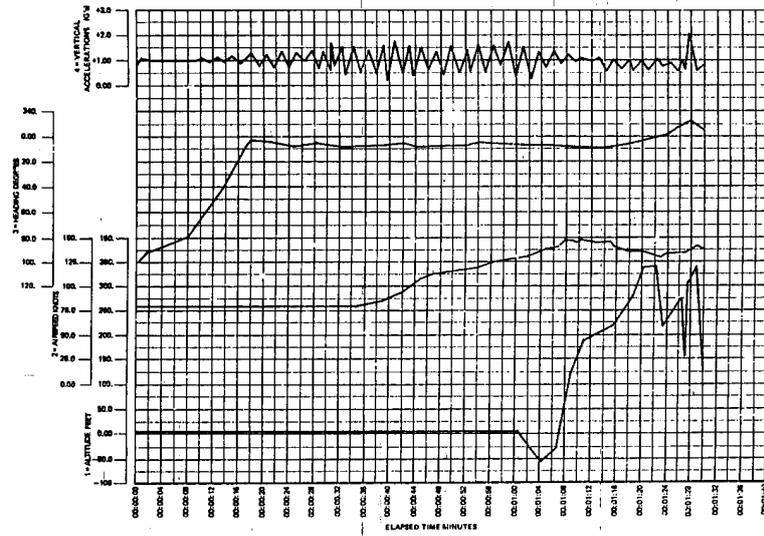
Appendix E Flight Data Recorder Graph

The recorders were only superficially damaged. The foil recording medium was removed from the FDR and examination disclosed that all parameters and binary traces were present and active. The altitude and airspeed traces were derived from the aircraft central air data computer. Other data recorded were magnetic heading, vertical acceleration, and radio transmitter (microphone) keying, all as a function of time. (The FDR readout is presented in appendix E.)

The FDR showed a sharp decrease and then a gentle rise in the altitude trace beginning at 1600:31.6 (0002:00.6); this is characteristic of the change in static pressure caused by aircraft rotation. Airspeed at this time was recorded as 130 knots. The V_2 callout occurred at 1600:37, and the sound of the stall warning (stickshaker) began 2 seconds later and continued until impact.
